Snake River Sporting Club, LMO 1117
NW¼SE¼ Sec.32, T.39N., R.116W., Teton County, Wyoming
Unreclaimed Mining Disturbances as of 2009

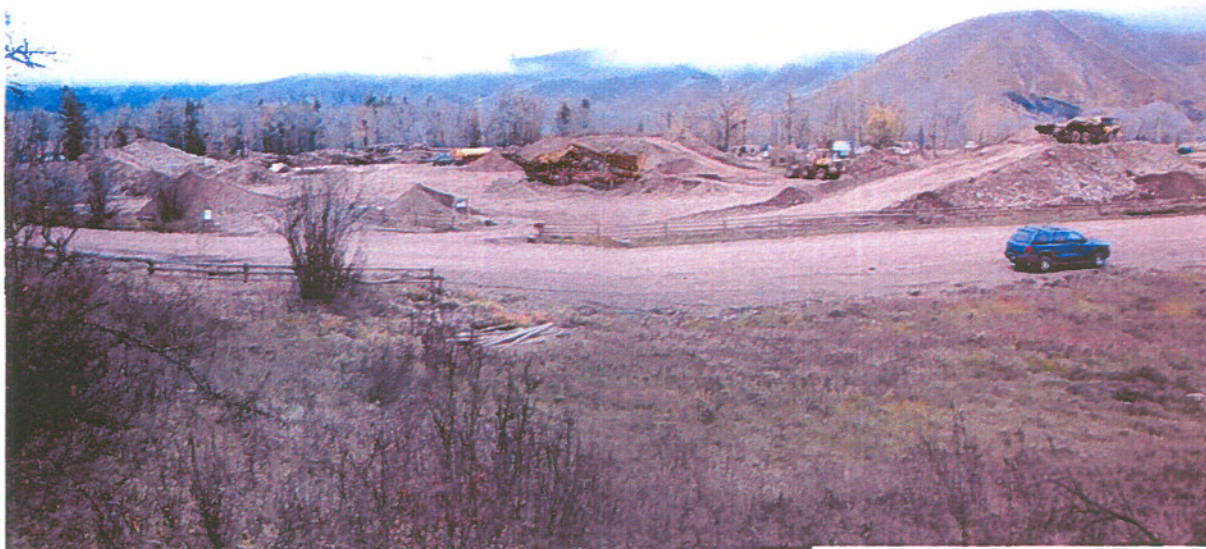
Figure 1 - View of the 1117ET gravel processing area on October 24, 2007.

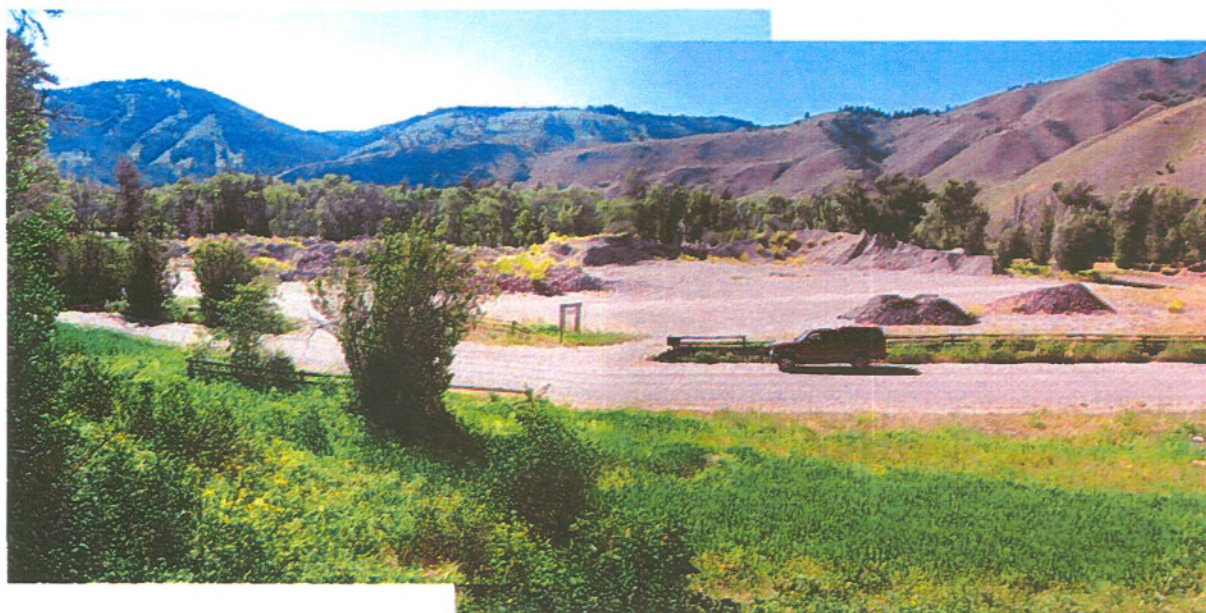
Figure 2 - View of the same area during the current inspection on July 15, 2010

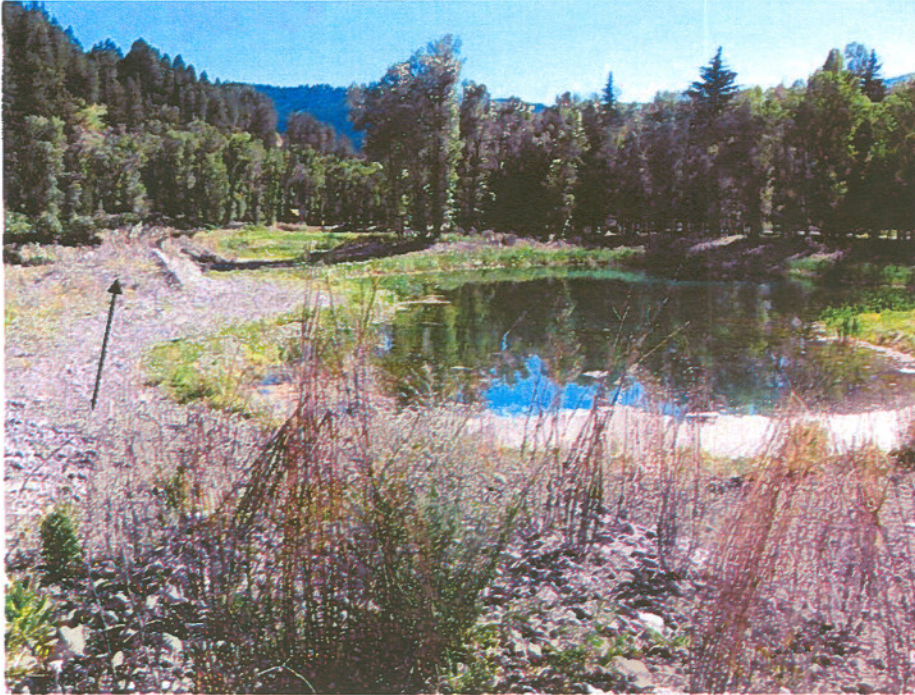
Figure 3 - View S of Pond No. 1 (see attached map). A topsoil stockpile is evident to the left of the pond (arrow).

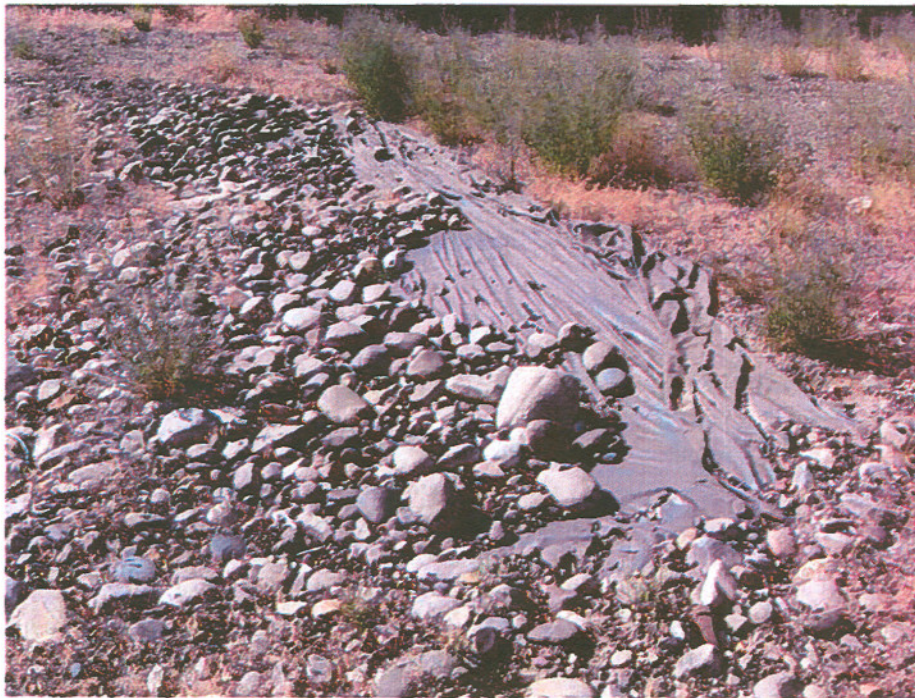
Figure 4 - View of uncovered liner

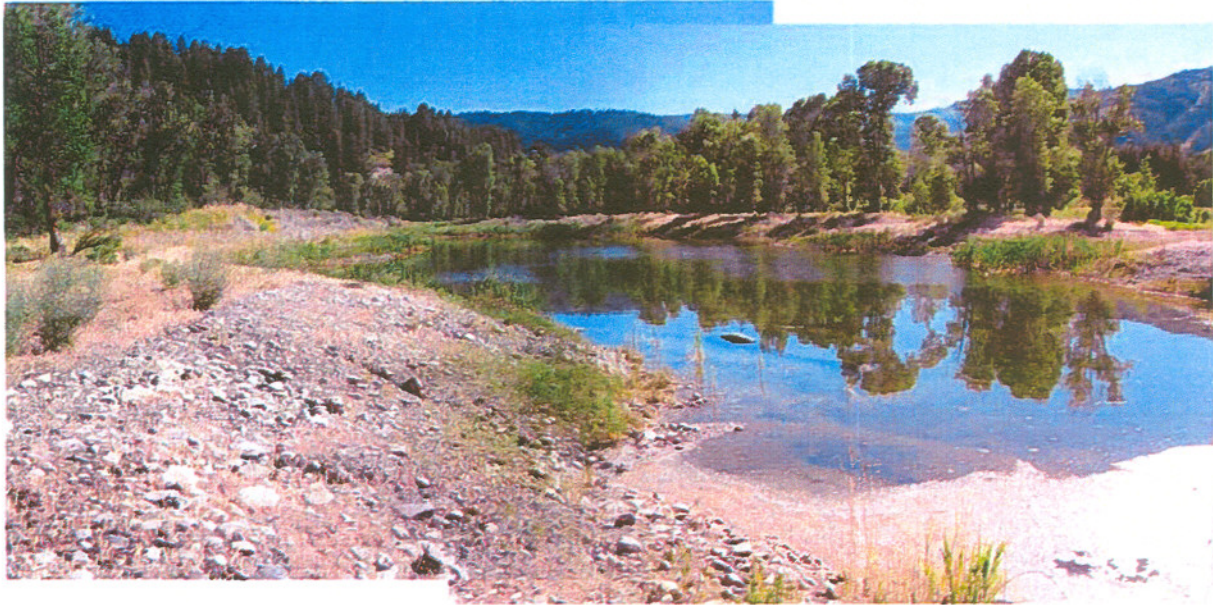
Figure 5 - View S of Pond No. 2. Topsoil is stockpiled adjacent to the pond on the left.

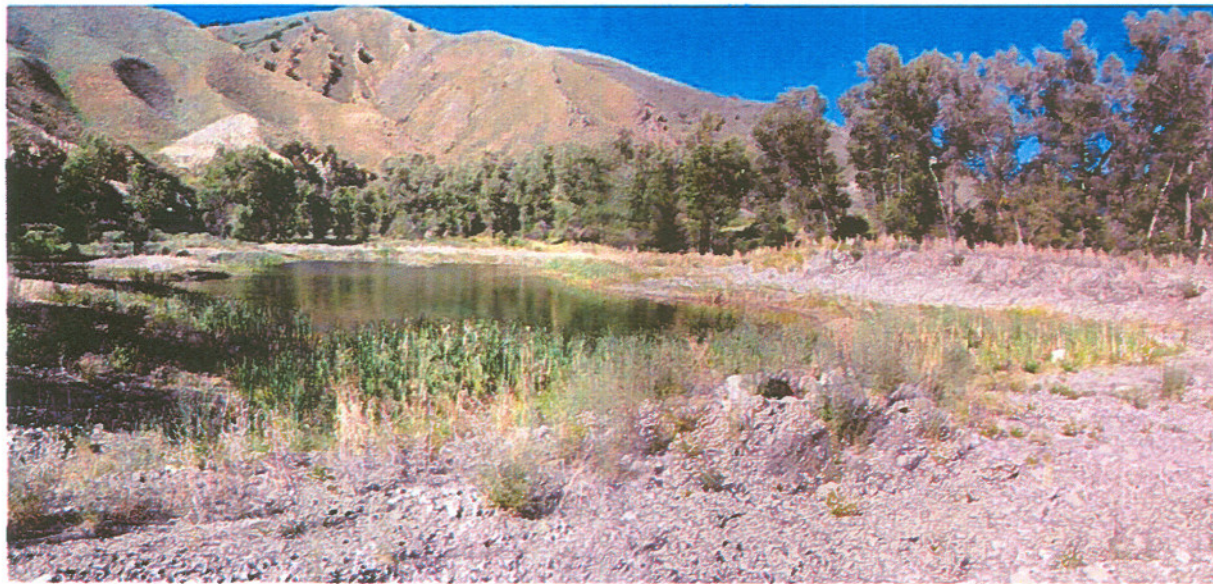
Figure 6 – View N of Pond No. 3. Topsoil is stockpiled on the right in this view.
