INSPECTION FORM

: Carbon Energy, Scoria Pit, Limited Mining Operation #578ET

DATE OF INSPECTION: September 10, 2007

: Steve Platt, Environmental Senior Analyst, WDEQ-LQD District 2

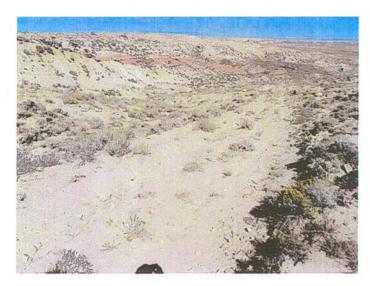
Photo 1. View looking east across the upper portion of the access road toward the scoria outcrop & scoria trench. eFrame IMG_0553.

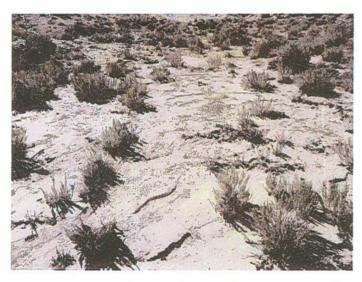
Photo 2. View of minor native drainage up stream of the access road and culvert where background sheet erosion was extensive. eFrame IMG_0565 .

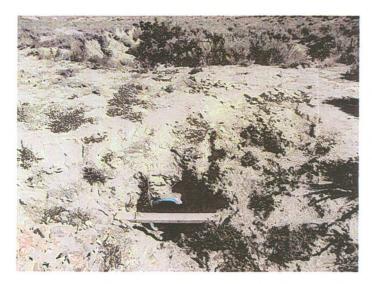
Photo 3. View of upstream end of the culvert under the access road where erosion was minor. eFrame IMG_0559.

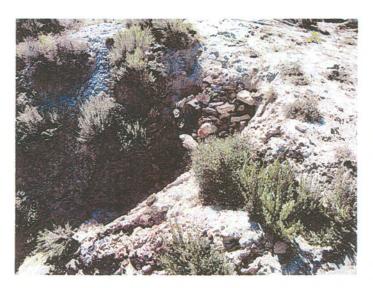
Photo 4. View of downstream end of the culvert under the access road where erosion was ongoing. eFrame IMG_0560.

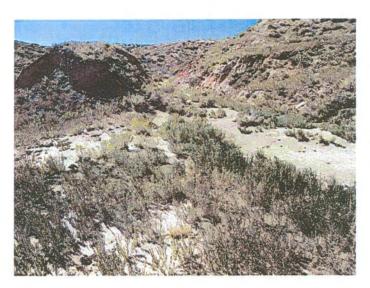
Permit/License No.: 578ET			Inspection Date: 9/10/07
Mineral : Sand & Gravel			REC
Operator: Carbon Energy			Date Permit Issued: 5/23/85 Acres: 2.4
Licensee: NA			Last Annual Report Received: 4/01/99
Pit Name: Scoria Pit			Date of Last Inspection: 7/18/97
Inspector Name: Steve Platt			Current Bond Amount: \$1,000 [\$300/acre]
Participants: <u>NA</u>			Landowner: Private State Federal
Status: Active In Reclama	tion [☐ Inactive ☐ Abandoned	Mineral Owner: ☐ Private ☒ State ☐ Federal
A	dequate	2	Comments
Permit Signs	No		
Topsoil Signs	No		
Topsoil Salvage	√ -√	Three topsoil st	tockpiles present.
Topsoil Protection			
Native Disturbance	No		
Erosion	√		nighly erosive; some sheet erosion on-site & in areas (Photo 2).
Roads & Culverts	√	Access road ha	s eroded & channel below road culvert (Photos 1, 3 &
Impoundments	No		
Highwalls	√	Approximately	12 feet tall in excavated trench (Photos 5 & 6).
Blasting	N/A		
Solid Waste on site	N/A

Photo 5. View looking west along the excavated trench where highwalls were present. eFrame IMG_0562.

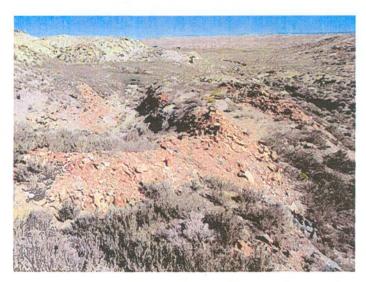
Photo 6. View looking east along the scoria trench where highwalls were present. eFrame IMG_0564.
