MINE:

Melvin Gustin, Permit 310c

September 23, 2011

Melvin Gustin - 310c September 23, 2011 Inspection Report Date: October 5, 2011

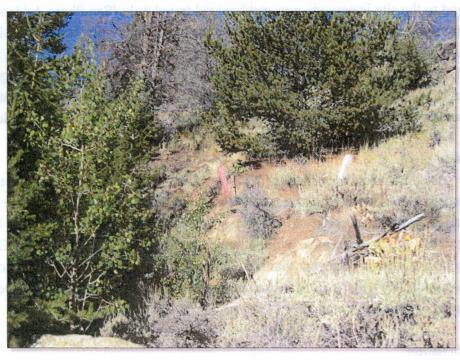
As revealed in the attached Photo Addendum, the site's pits have healed and are well-vegetated. However, the Forest Service has indicated the need for the installation 15-20 water bars along the site's access road. Over the past five (5) years, WDEQ/LQD personnel have tried to communicate the need to complete this reclamation work to Mr. Gustin, to no avail. Mr. Gustin has refused delivery of mail correspondence from the WDEQ since 2007. Failure to reclaim affected land as mining progresses in conformity with the approved reclamation plan is a violation of W.S. §35-11-415 (b)(ix). In light of this violation, a Notice of Violation (NOV) will be sent under separate cover.

Photo Number 1: This depicts one of the healed overgrown excavation sites dug under Permit 310s. The claim post can be seen in the center of the photo.

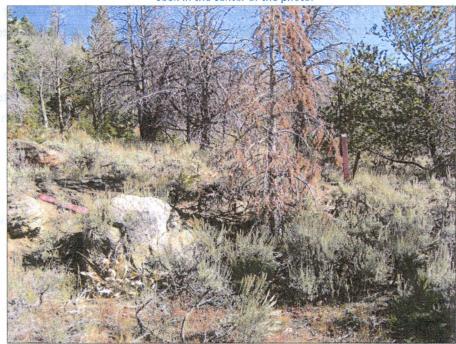
Photo Number 2: This depicts another overgrown excavation site associated with Permit 310s.

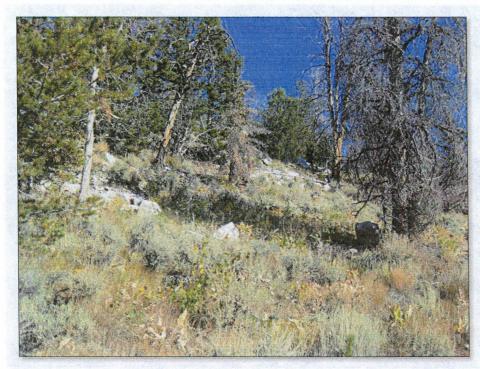
Photo Number 3: This depicts a third excavation site dug under Permit 310s. The quartz outcrop can be clearly seen.

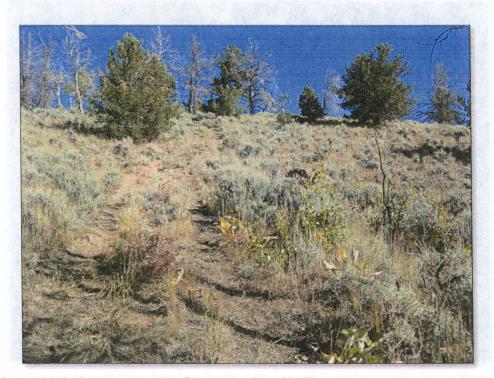
The access road to the site is now via non-mechanized travel only (See Photo Addendum). The road leading up to the seven identified excavation sites associated with Permit 310s is very steep and crosses numerous small ephemeral drainages. These crossings all could benefit from the installation of water bars. The actual excavation sites have grown in with native vegetation and are not a concern. It is only the need for water bars on the two-track access road that is the outstanding concern with Permit 310s. Refer to the attached Photo Addendum for details.

Photo Number 4: This depicts a steep portion of the two-track road leading to the upper three excavation sites dug under Permit 310c. This is one of the several locations along the access route that is in need of a water bar.

The currently posted bond in the amount of \$200 was the statutory maximum at the time the permit was issued. It is likely deficient to complete the work required at the site (the installation of 15-20 water bars on the access road). The required work will probably cost the US Forest Service about \$500. No bond increase will be made, however, because WDEQ/LQD will be pursuing a bond forfeiture in the event that Mr. Gustin refuses delivery of the forthcoming Notice of Violation (NOV) that will be issued for the failure to reclaim the site in accordance with the approved reclamation plan.

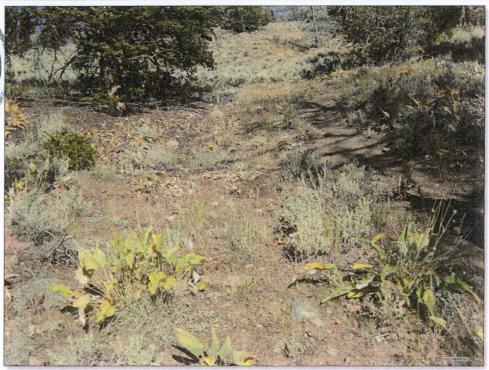
Photo Number 5: This is another portion of the access route in need of a water bar.

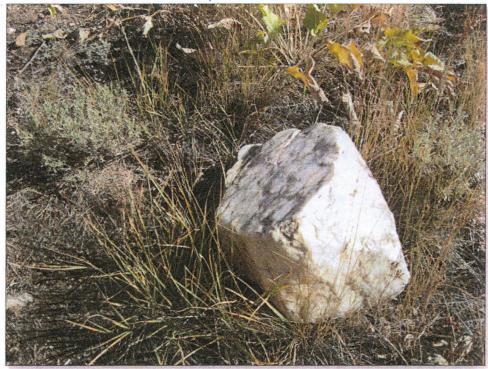
Photo Number 6: This depicts the quartz (silica) that is found as "float" material downhill from Mr. Gustin's excavation sites.

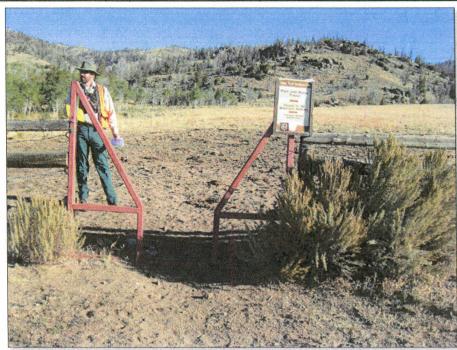
Photo Number 7: This depicts the gate at the section line between Sections 31 and 30 T. 43N, R.104W that prevents vehicular access to the area.

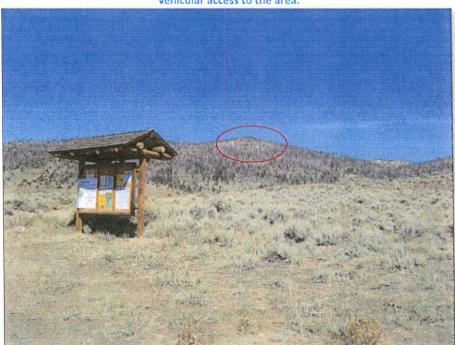
Photo Number 8: This depicts the hillside on which Mr. Gustin's Permit is located (red oval), as viewed from down below at the parking area just south of the section line between Sections 30 and 31.
