WYOMING DEPARTMENT OF ENVIRONMENTAL QUALITY
LAND QUALITY DIVISION -- INSPECTION REPORT

MINE: ORO Management (ORO), LLC, License to Explore 238LE

DATE OF INSPECTION: September 19, 2011

Photo Addendum to accompany 2011 Annual Report for ORO Management's 238LE

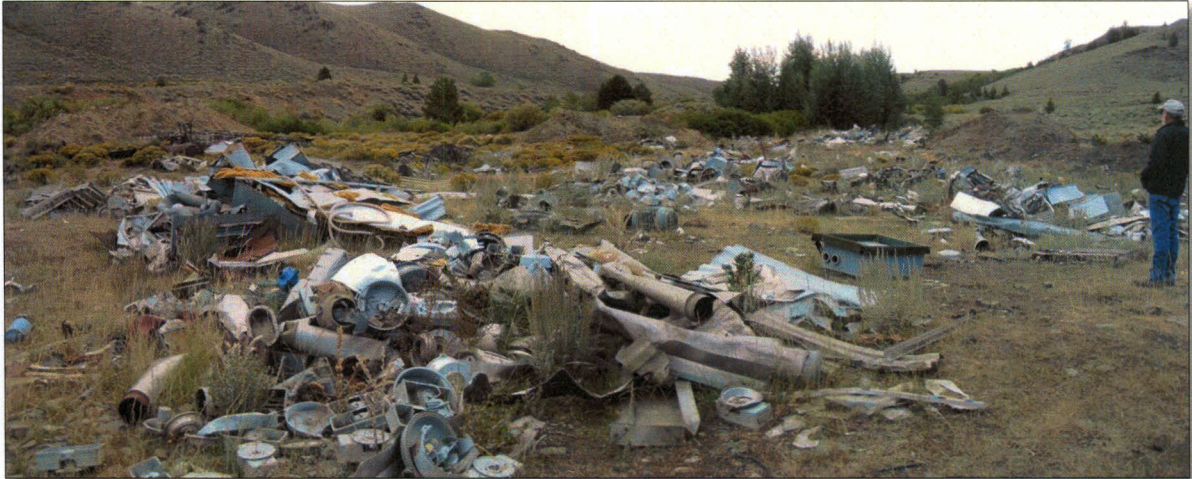
Photo Number 1: This depicts an area east of the processing area where scrap aluminum is stored. This view is looking toward the southeast.

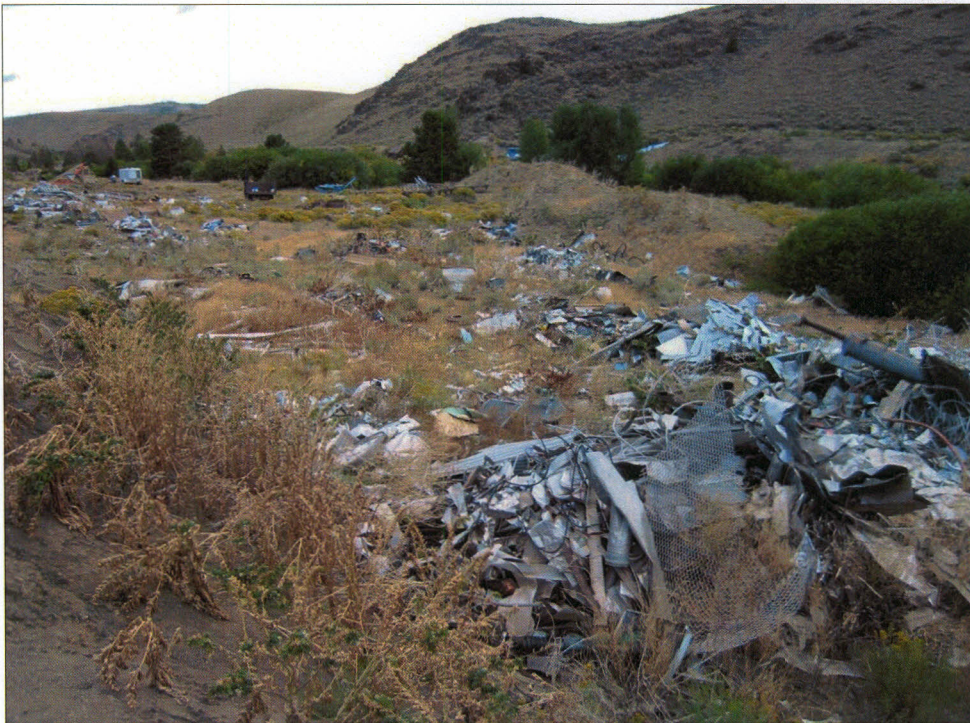
Photo Number 2: This is another view of the aluminum scrap area. This view is looking to the northwest.

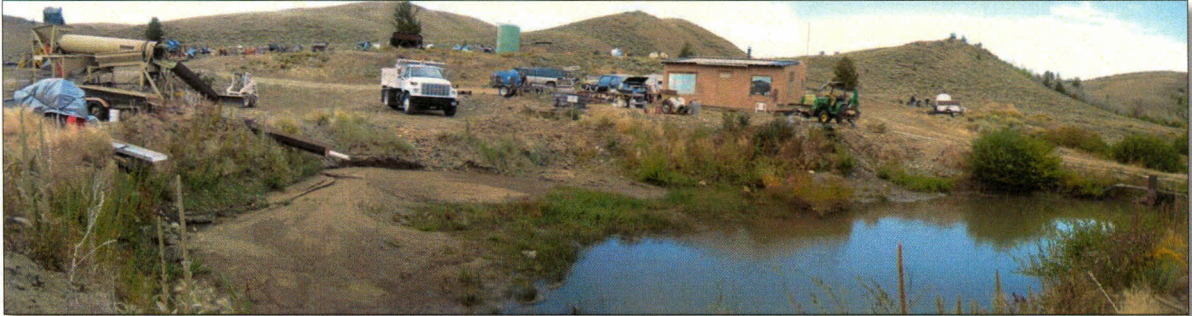
Photo Number 3: This depicts the easternmost processing/settling pond.

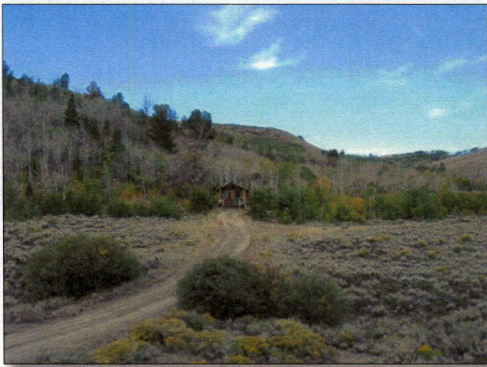
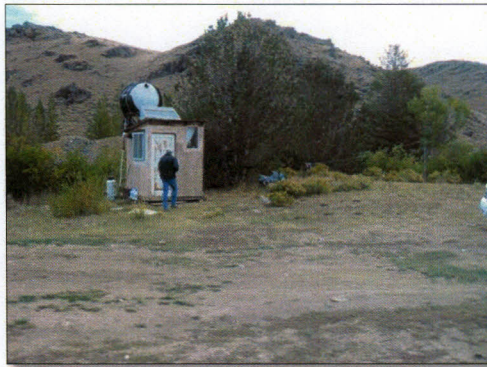
Photos Numbered 4a and 4b: The photo on the left depicts a cabin that has been placed to the west of the processing area. The photo on the right depicts an outhouse that is located north of the cabin, also west of the processing area. It is believed that this cabin is occupied by Roger, the site watchman. LQD understand that the placement of these structures has not been authorized by Mr. Bixler, partial owner of this property.

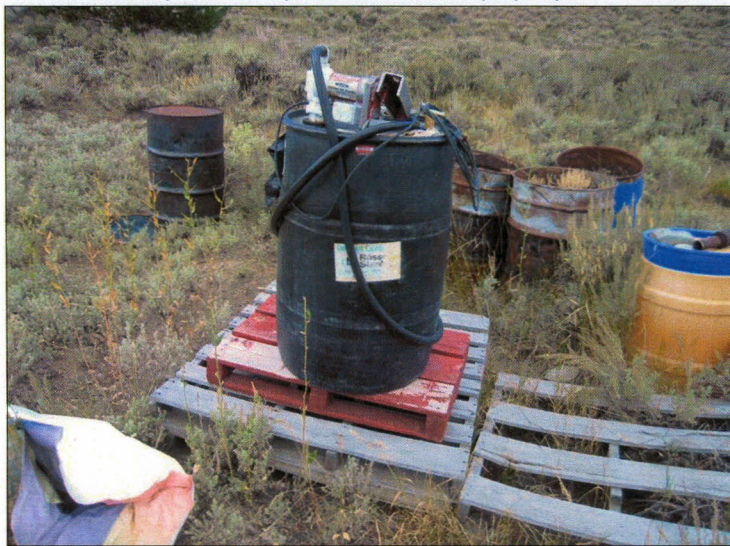
Photo Number 5: This depicts a plastic drum whose contents are unknown. The drum was noted, during this inspection, as having some type of liquid stored in it.

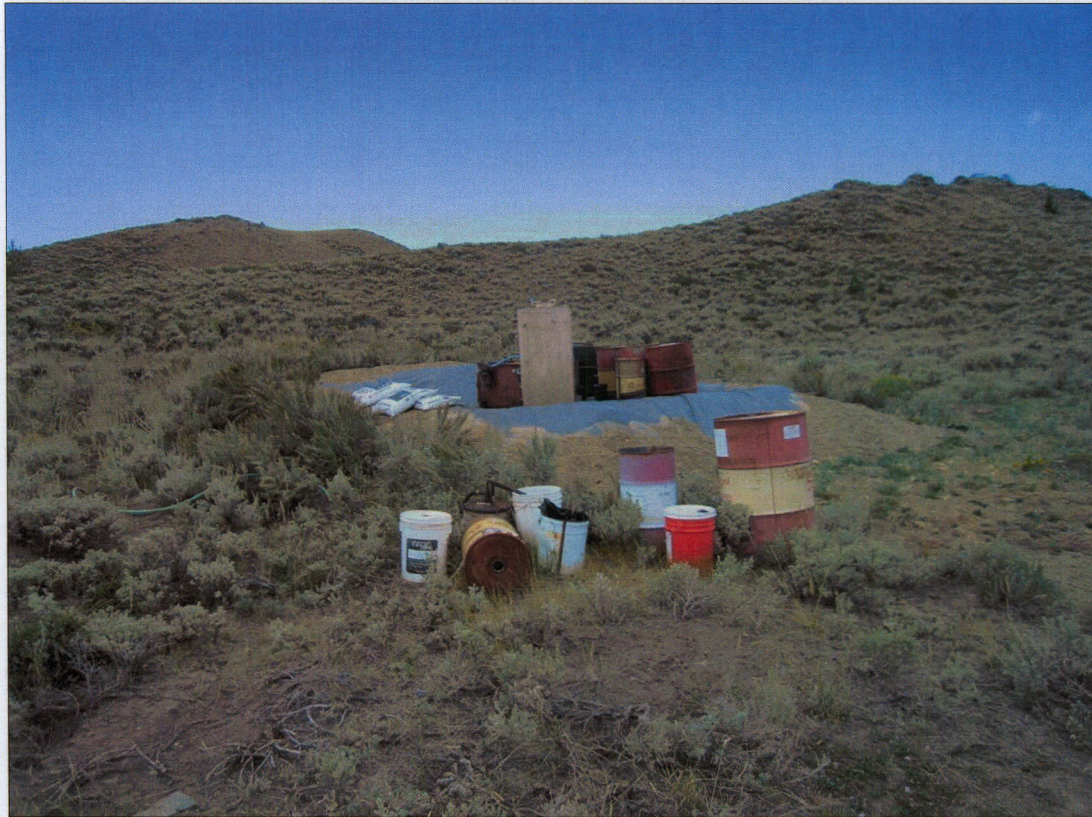
Photo Number 6: This depicts one of the hydrocarbon storage areas at the site. The upper portion at this location is the lined/bermed area mentioned in the text.

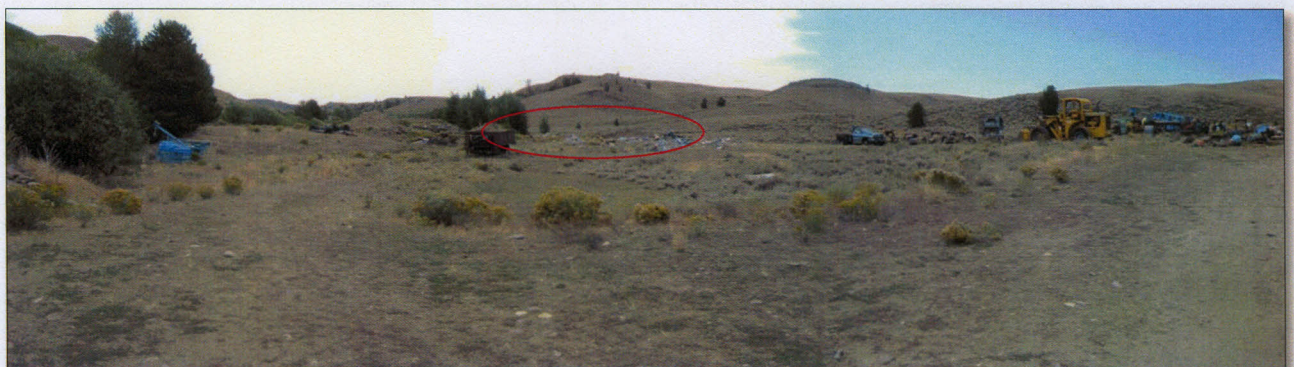
Photo Number 7: This is a view of the eastern portion of the site. It is a panoramic looking from east-northeast to the south. The aluminum scrap pile depicted in Photo Number 1 is noted by the red oval. The vantage point of this panoramic view is from the center of the site. The processing area/ponds are to the right of this viewpoint.

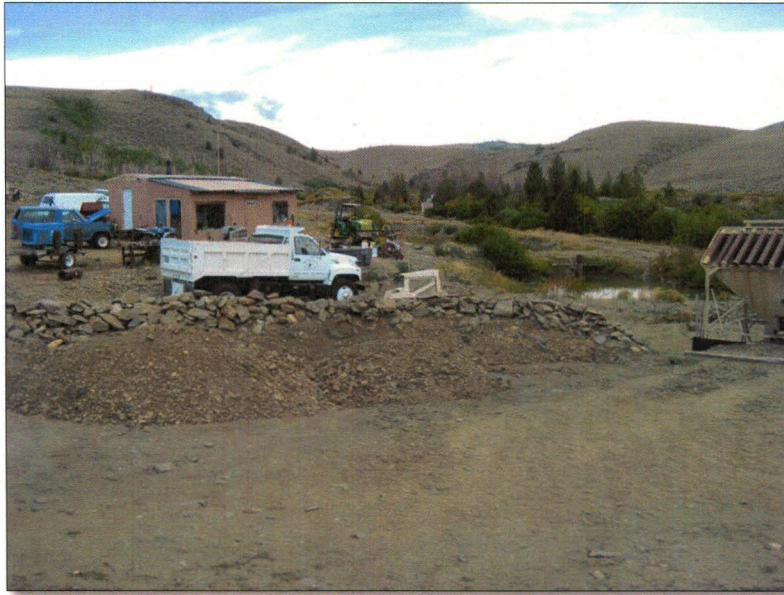
Photo Number 8: This depicts the stockpile and processing area. The “first pond” (easternmost settling pond) can be seen in the top right of this photo. The view is looking to the southwest, from the same vantage point as Photo Number 7.

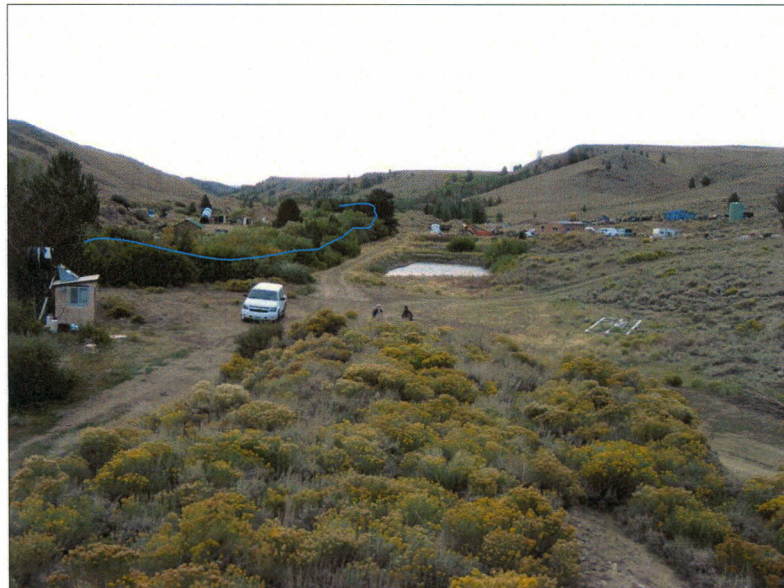
Photo Number 9: This is a view of the entire site looking east from its west end. The vantage point is from the old dredge pile west of the site. The outhouse depicted in Photo Number 4b can be seen on the far left side of this picture. The blue line denotes the path of Rock Creek (beneath the vegetation). Thus, it can be seen that there is solid waste stored south and north of Rock Creek. And the outhouse is adjacent to Rock Creek.

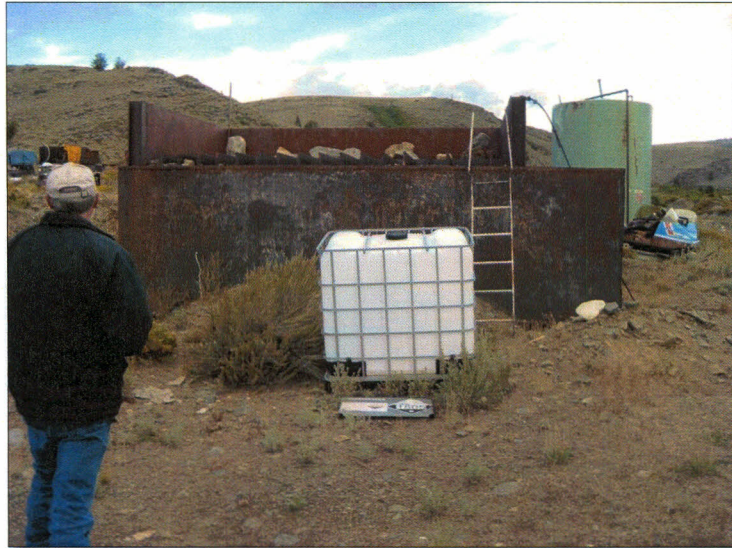
Photo Number 10: This depicts a plastic container with approximately six inches of fluid in it. Its placard has the number 1805 on it which is the corrosive, Phosphoric Acid.

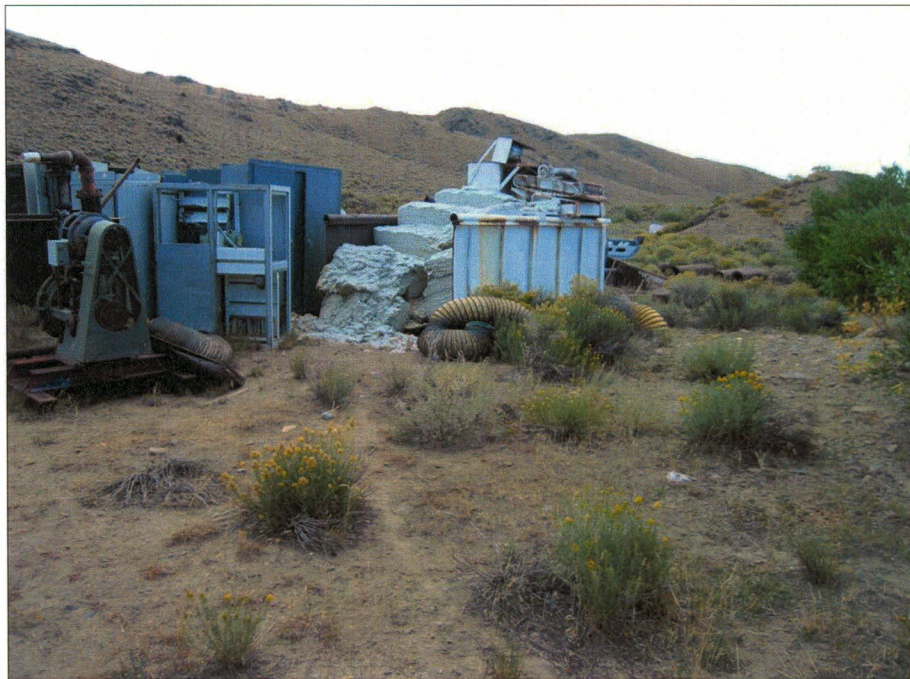
Photo Number 11: This depicts some other scrap materials stored on the site.

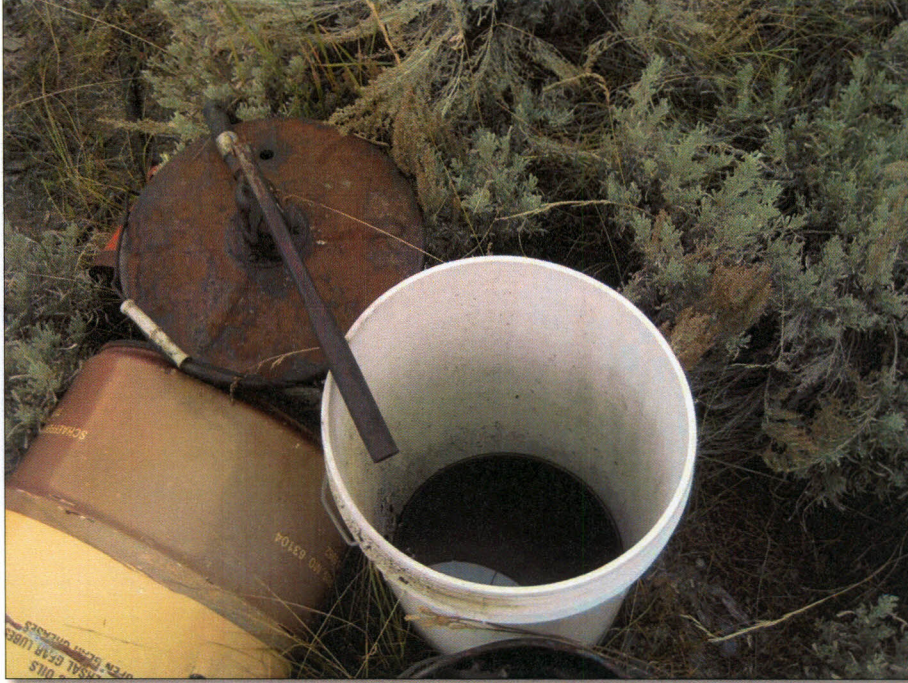
Photo Number 12: This depicts a five-gallon bucket with some kind of hydrocarbon in it. There is no lid on this bucket.

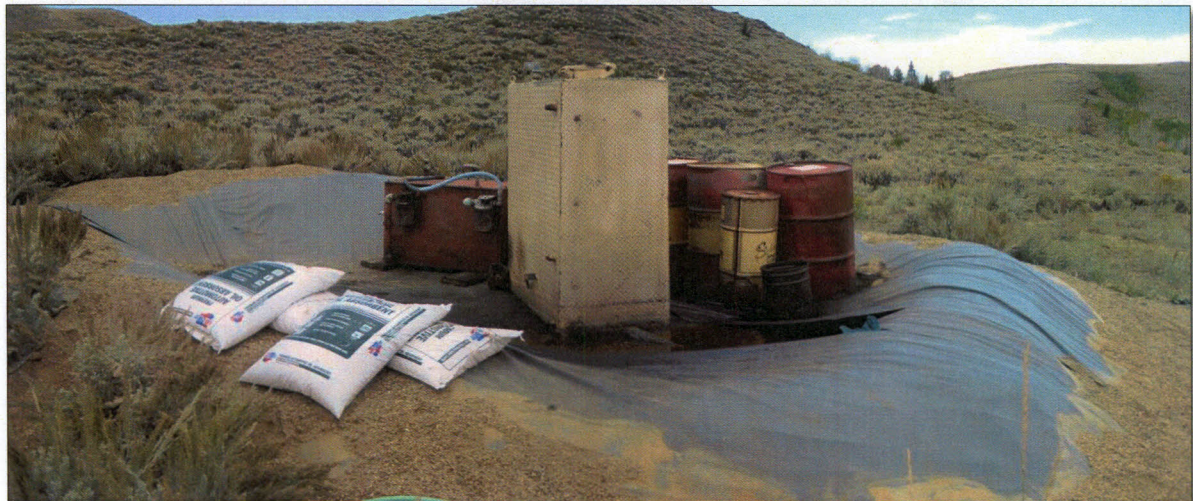
Photo Number 13: This depicts the hydrocarbon storage area that was bermed and lined in August 2010 and documented via pictures sent to LQD by Carl Anderson. There is a break in the liner, a close up of which is depicted in Photo Number 14.

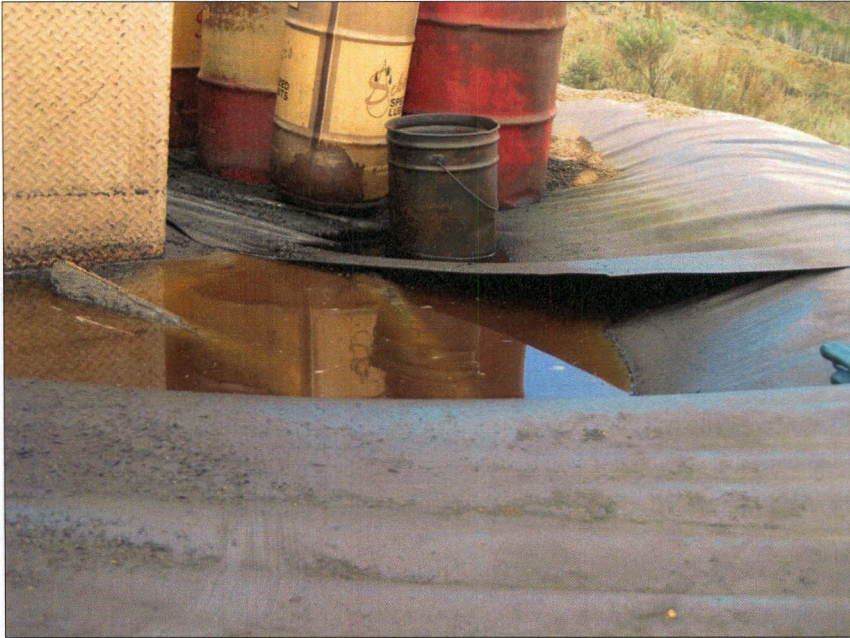
Photo Number 14: This is a close up of the liner depicted in Photo Number 13.

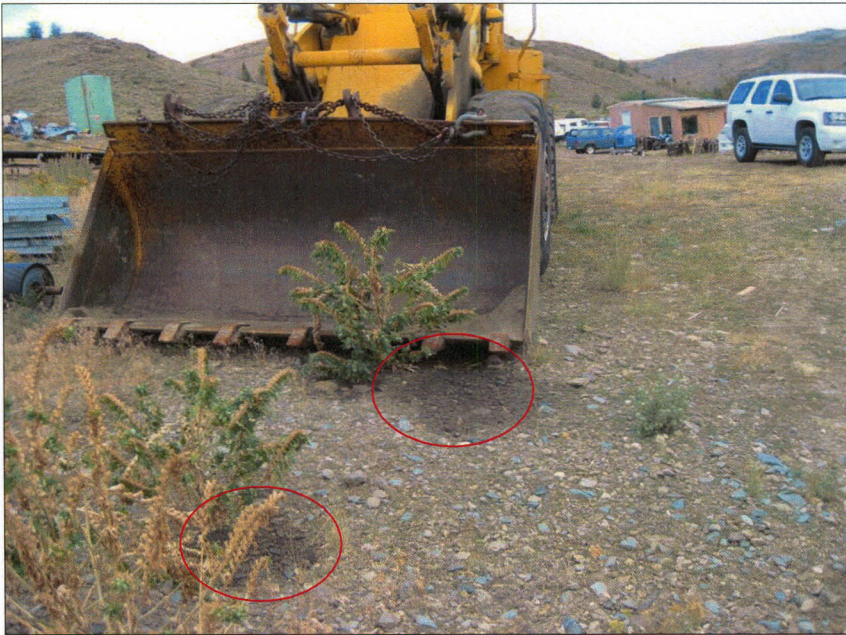
Photo Number 15: This depicts two of several petroleum-contaminated soil stains (red ovals) noted at the site. There is also the noxious weed, Henbane in this picture.

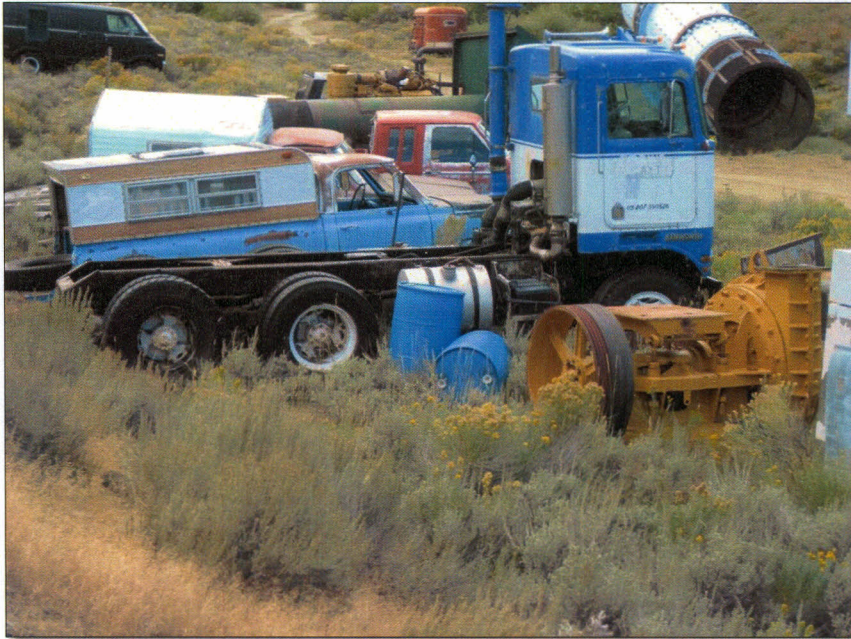
Photo Number 16: This depicts some of the abandoned vehicles parked north of Rock Creek at the 238LE site. In front of the blue and white truck in the foreground of this picture is a spot of PCS, a close-up of which is provided in Photo Number 17.

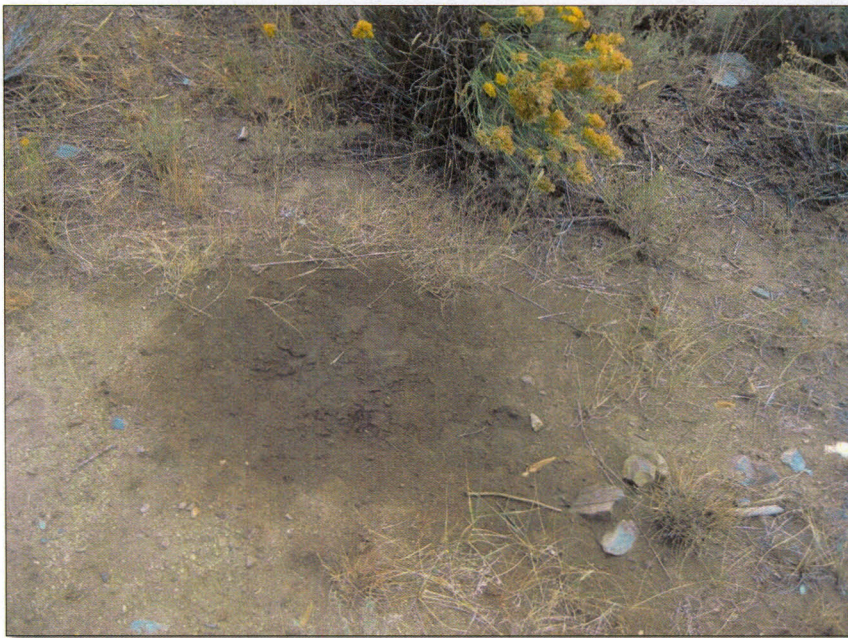
Photo Number 17: This depicts a close-up of the PCS in front of the blue and white truck depicted in Photo Number 16.

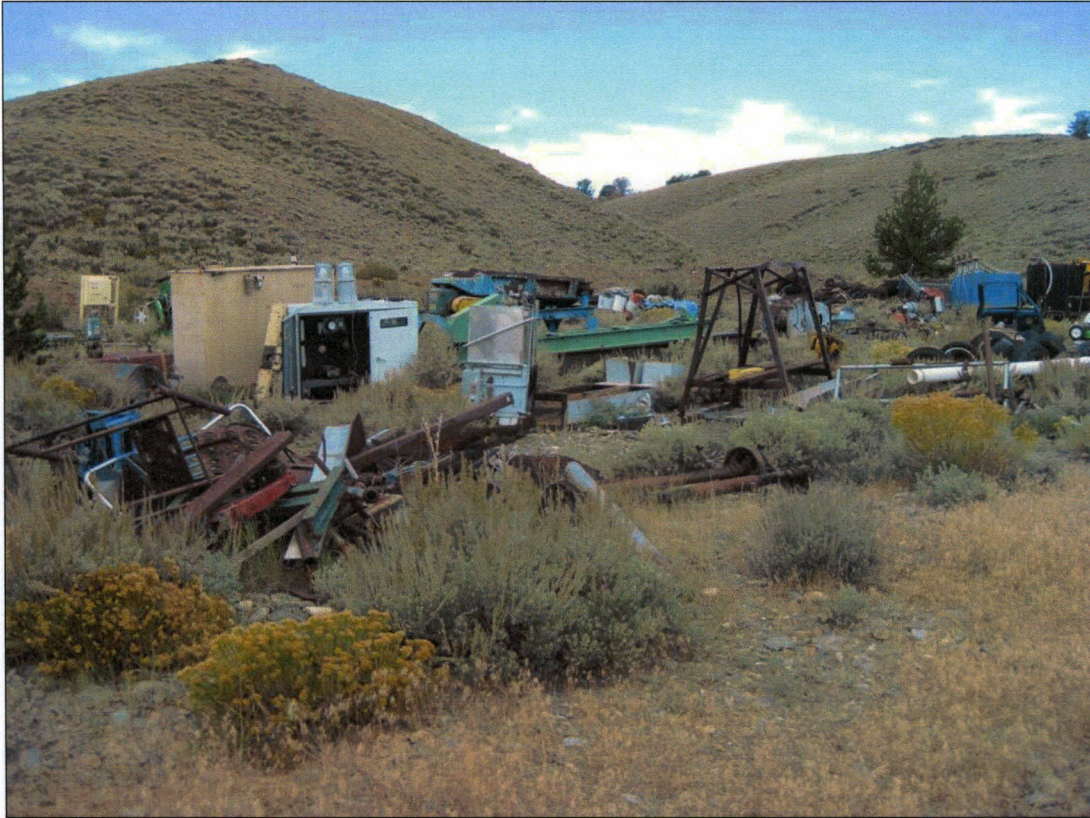
Photo Number 18: This depicts more of the solid waste stored north of Rock Creek at the 238LE site.

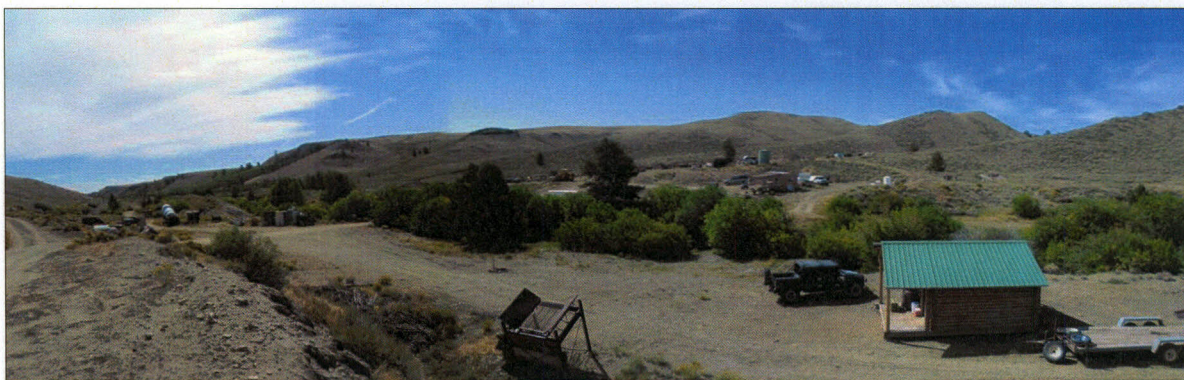
Photo Number 19: This is a view looking east from the road leading to the site. It depicts the solid waste stored north of Rock Creek.

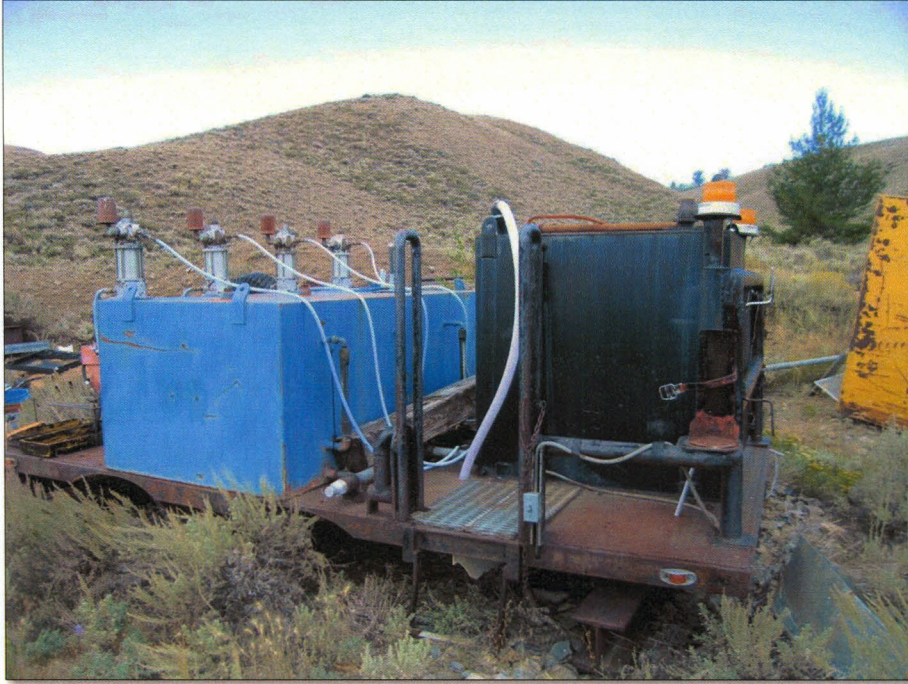
Photo Number 20: This depicts another items stored on site.
