Lost Creek ISR, LLC
Littleton, Colorado USA

FIGURE MU1 4-2c
Monitor Well Re-Completion
Type 3 - Screen Inside and
Outside Casing

Lost Creek Permit Area
 Issued For: WDEQ-LQD MU1 Drawn By: SMH
 Issued / Revised: 01.20.2011
 Dwg # WDEQ-LQD MU1 FIG MU1 4-2c 1.20.11 SMH

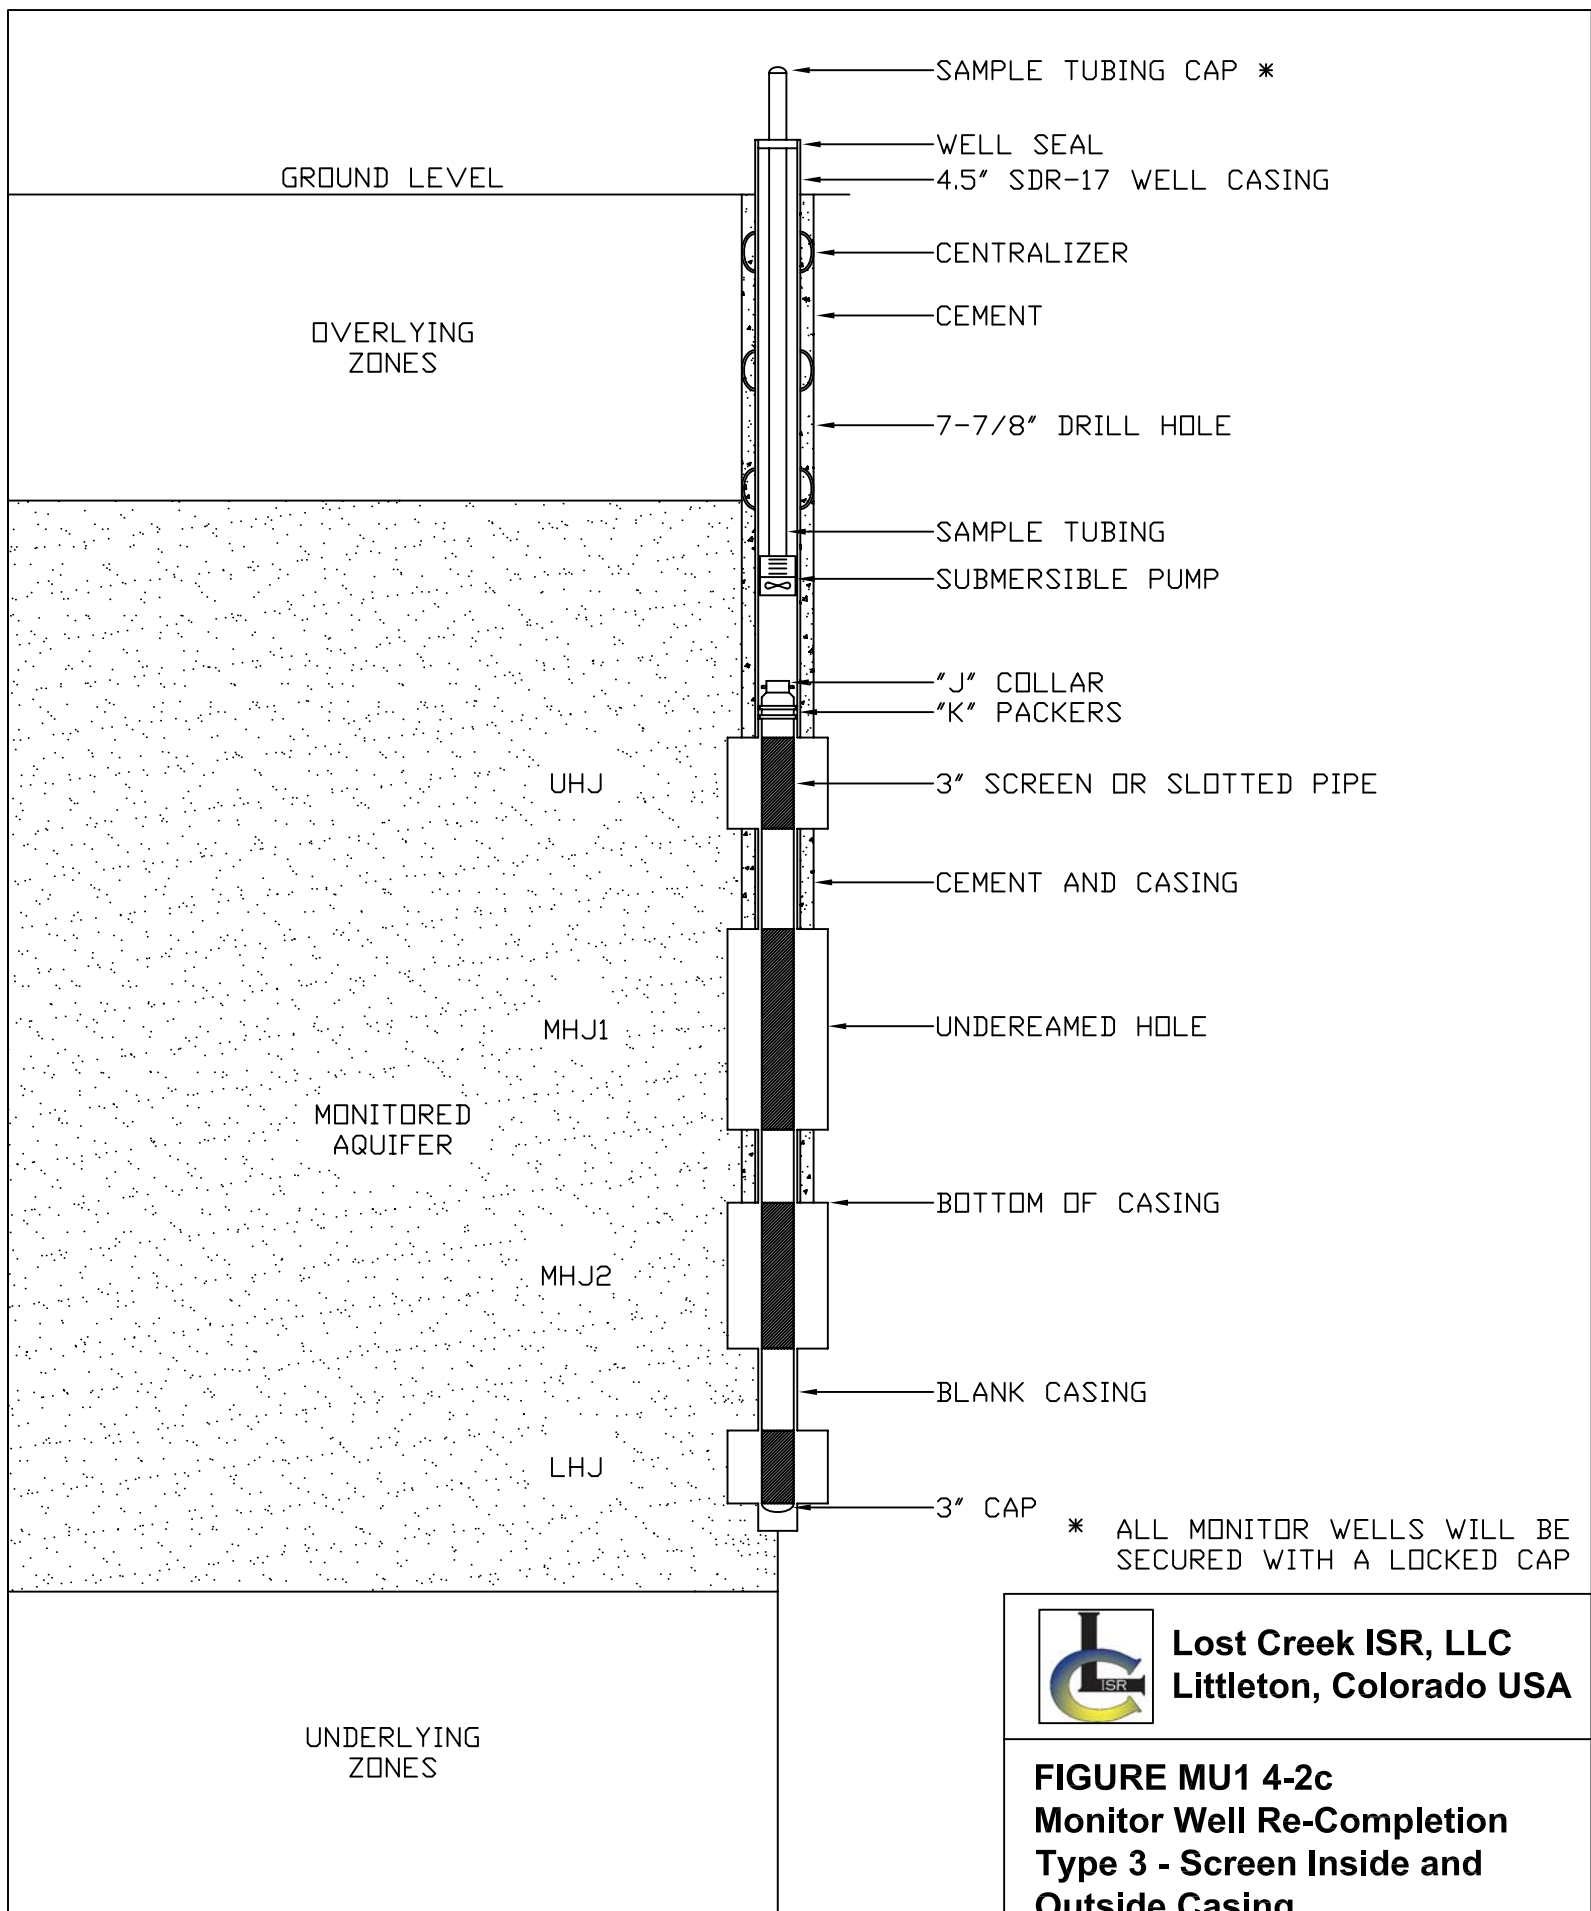
* ALL MONITOR WELLS WILL BE SECURED WITH A LOCKED CAP
