Lost Creek ISR, LLC  
 Littleton, Colorado, USA

**FIGURE D6-27a**

**Piper Diagram - Average Water Quality at Individual Monitor Wells**

**Lost Creek Permit Area**

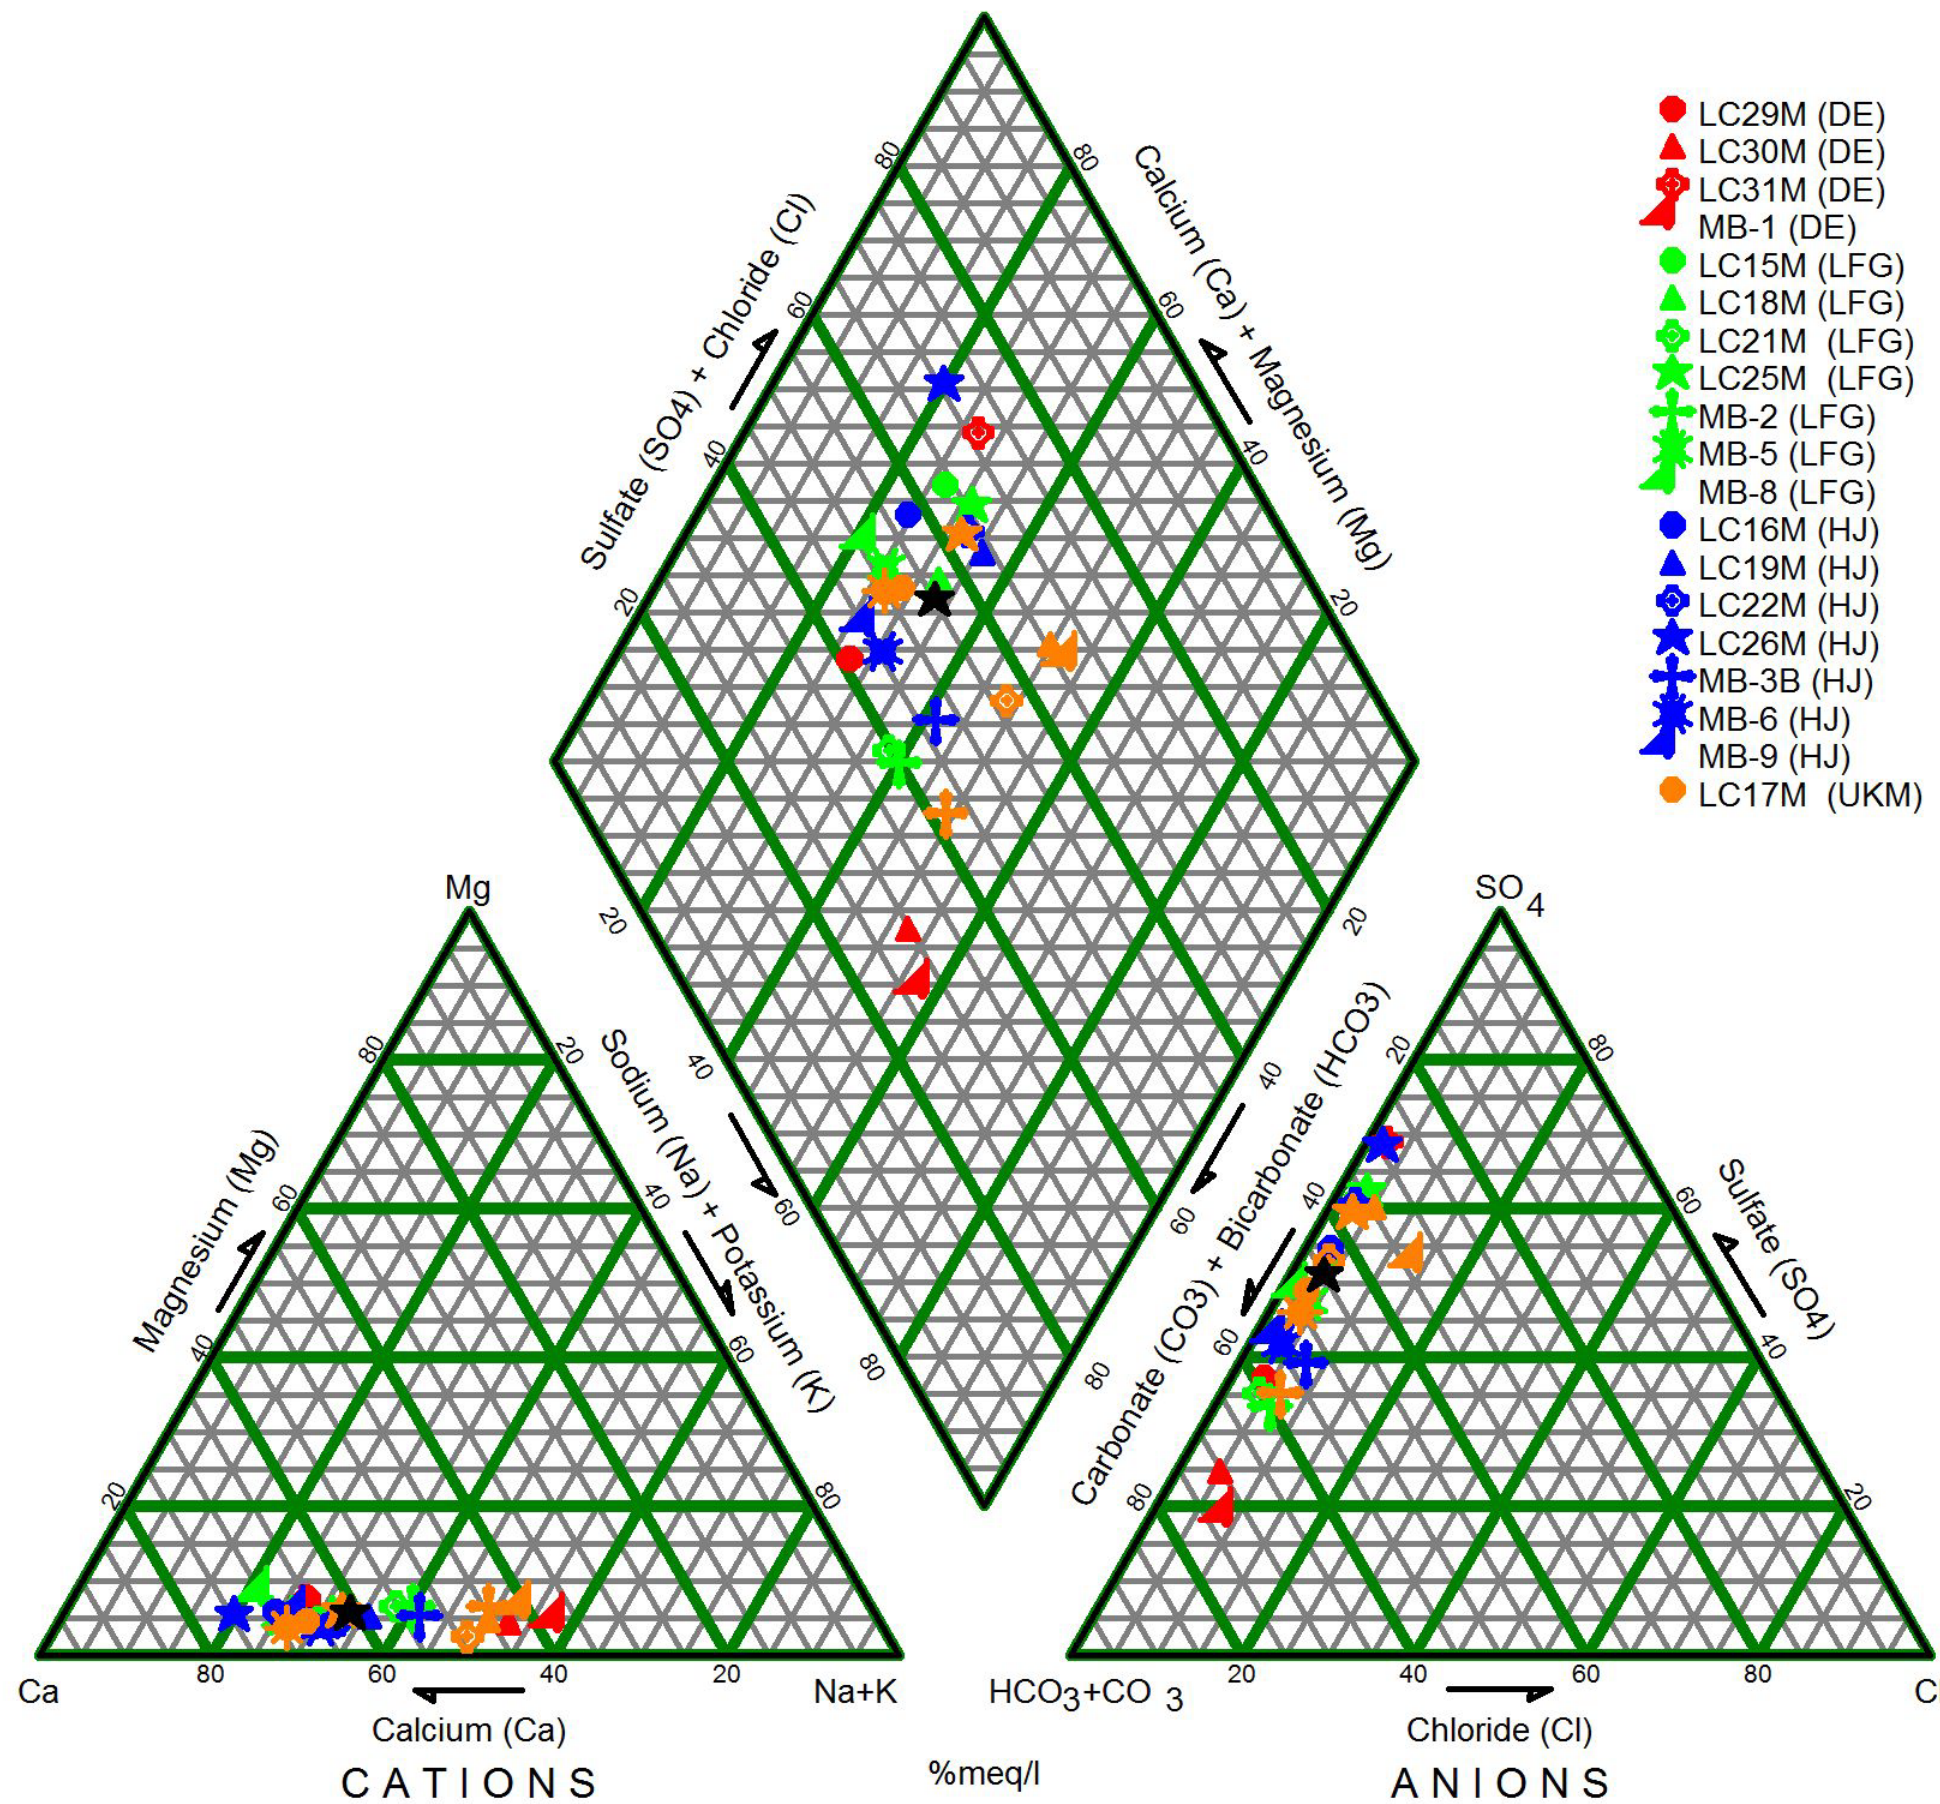
- LC29M (DE)
- ▲ LC30M (DE)
- ◆ LC31M (DE)
- ◆ MB-1 (DE)
- LC15M (LFG)
- ▲ LC18M (LFG)
- ◆ LC21M (LFG)
- ◆ LC25M (LFG)
- ◆ MB-2 (LFG)
- ◆ MB-5 (LFG)
- ◆ MB-8 (LFG)
- LC16M (HJ)
- ▲ LC19M (HJ)
- ◆ LC22M (HJ)
- ◆ LC26M (HJ)
- ◆ MB-3B (HJ)
- ◆ MB-6 (HJ)
- ◆ MB-9 (HJ)
- LC17M (UKM)
- ▲ LC20M (UKM)
- ◆ LC23M (UKM)
- ◆ LC24M (UKM)
- ◆ LC27M (UKM)
- ◆ LC28M (UKM)
- ◆ MB-4 (UKM)
- ★ Average All Aquifers
